## **Repair Procedure**

## Safety Recall 5321K - Multi-Model Fuel Pump May Fail - MX-5 ONLY

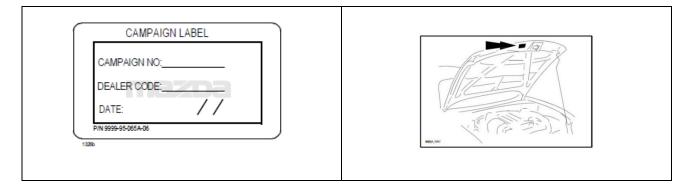
- If the vehicle is one of the above listed, proceed to Step 2.
- If the vehicle is not within the above ranges, return vehicle to the customer or inventory.
- 2. Perform a Warranty Vehicle Inquiry using your eMDCS System and inspect vehicle for Campaign Labels **Recall 5321K** attached to the vehicle's hood. Refer to eMDCS System Warranty Vehicle Inquiry Results table below.

**NOTE:** Be sure to verify Recall number as the vehicle may have multiple Recall labels.

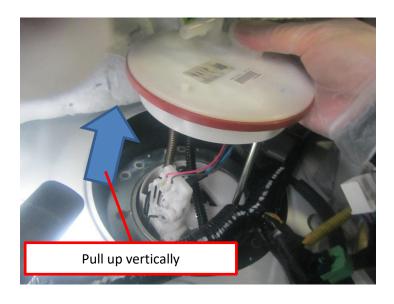
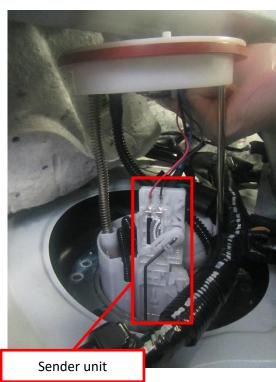
- 1. Remove the fuel pump unit from fuel tank refer to Workshop manual.
- 2. Pull up the fuel pump unit carefully until sender unit is appeared

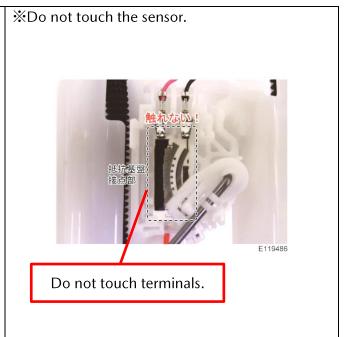
3, Hold the sender unit with harness up and go down the fuel pump unit vertically.

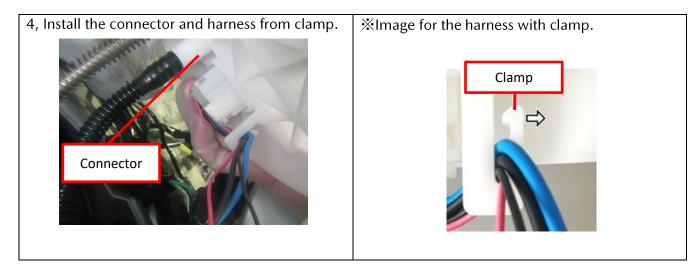
※Image of the groove and lock

- 3, Push down the sender unit vertically and check the following below.
- Make sure its inserted in the groove.
- There is the clicking sound from the 'Lock'

※Do not touch the sensor.
